## Colusa-Verona Reach

# Sacramento River Conservation Area and Inner River Zone Guidelines

Reach 4 (Colusa to Verona)

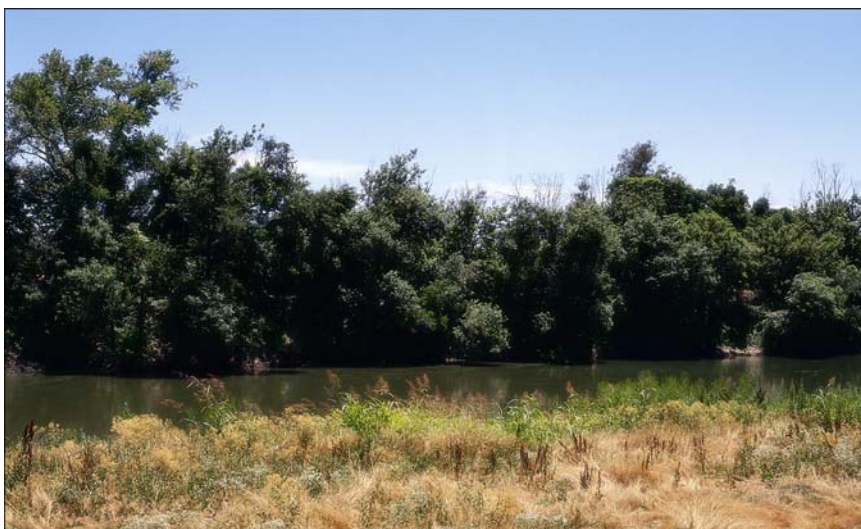
**Figure 6-2.** *Narrow “stringer” of riparian vegetation, Colusa–Verona Reach*

Much of the riparian habitat in this reach exists as narrow stringers along levees and levee berms (Figure 6-2). In some areas levees are set back from the water edge, affording opportunity for larger areas of riparian habitat. Local Reclamation Districts maintain many of these areas. Examples of high quality mature riparian habitat and SRA exist within the set back levees. Figure 6-3 (Moon's Bend) and Figure 6-4 (Downstream of Colusa Bridge) show examples of such habitat. Limited areas of restricted meandering of the river channel occur between RM 126 and 130, resulting in bands of successional stages. Other areas contain little riparian vegetation (Figure 6-5).

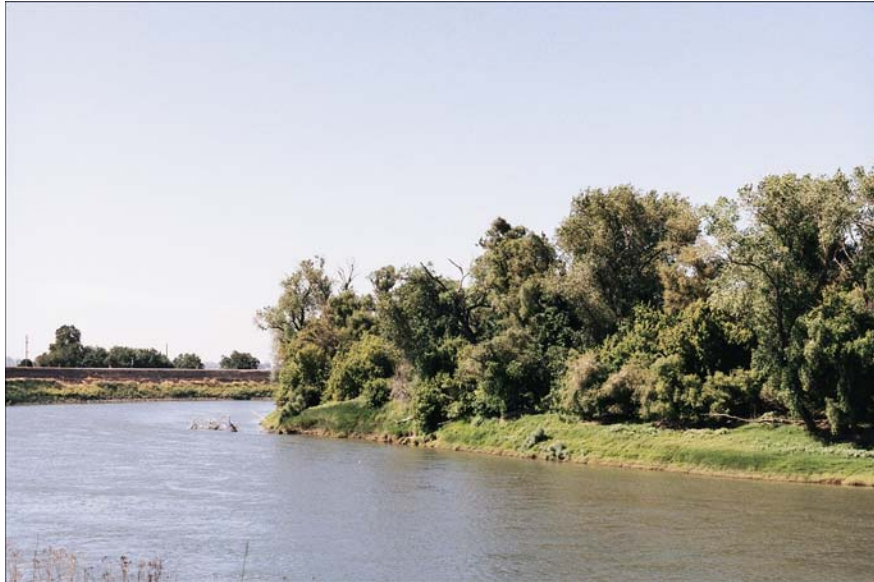
**Figure 6-3.** *Riparian vegetation near Moon's Bend (RM 138)*

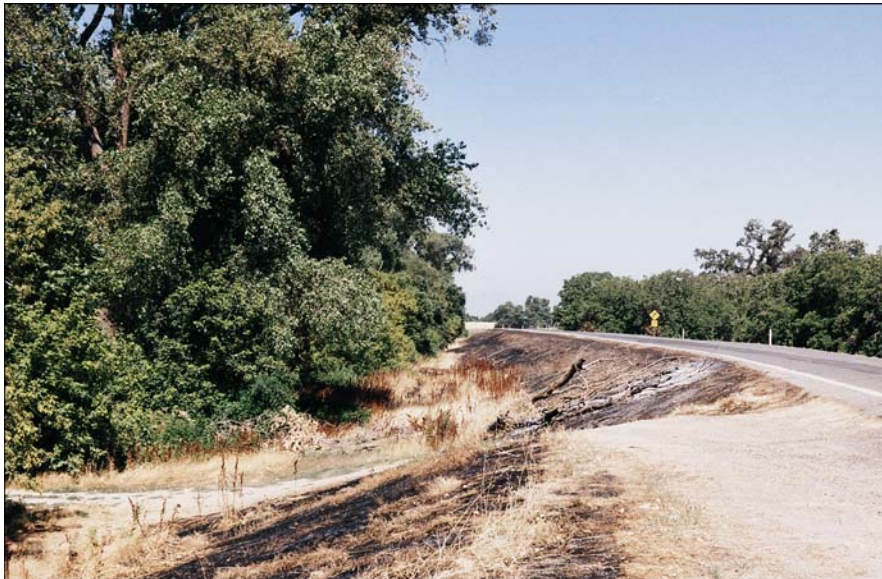
**Figure 6-4.** *Riparian vegetation on waterside berm, downstream of Colusa Bridge*

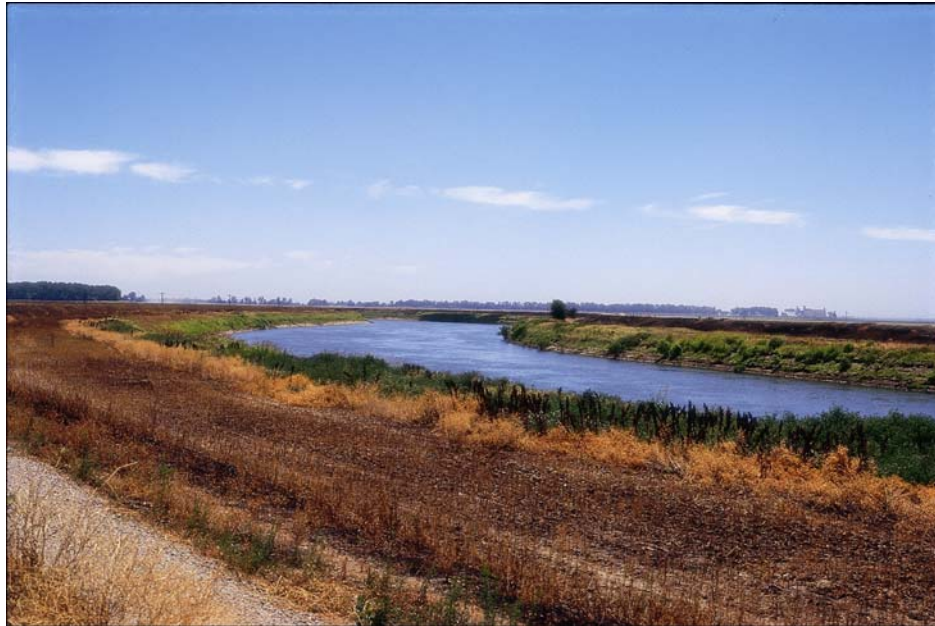
**Figure 6-5.** Area with little riparian vegetation, Colusa–Verona Reach
